## ANALYSIS OF ACCIDENT EVENT – AGRICULTURAL MACHINE AND MOTORCYCLIST

**Abstract.** During the harvest of agricultural crops, the number of tractors, harvesters and other agricultural machines on roads increases. Collision situations of agricultural machines and road vehicles occur most often. In the event of a collision between agricultural machines and more vulnerable road users, the consequences are more serious. For motorcyclists, the collision situation is much more dangerous and there is a greater likelihood of serious injury or death. According to expert evidence and the crash test results show that if, for example, a motorcyclist collides with a tractor at speeds higher than  $80 \text{ km}\cdot\text{h}^{-1}$ , the probability of survival is minimal. The most frequent collision situations are intersections, exits from the side road to the main road, exits from the main road to the side road, confusing turns. The paper deals with the analysis of an accident event of an agricultural machine (self-propelled harvester) and a motorcyclist at a left-hand turn, in the outskirts of the village. The origin is investigated and the course of the accident scene with reference to the r

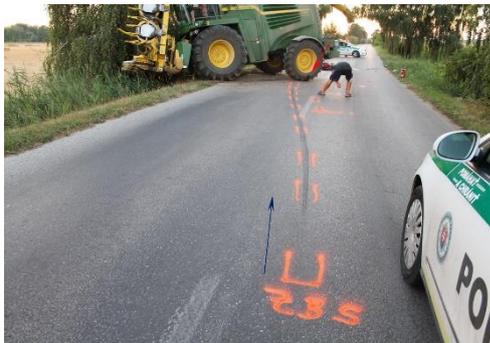
The traffic accident between a motorcycle and an agricultural machine occurred in the early evening on road III class, in the extra-villa section of the village, in the area of a left-turn bend, where the visibility conditions were reduced due to the vegetation located along the road. The agricultural machine moved without an accompanying vehicle, with the working part of the machine in a transport configuration. A motorcycle was moving in the opposite lane of the agricultural machine. The motorcyclist, during the moment of recognizing the character of the agricultural machine, and its overall width (extending into his lane), reacted with a startle effect and subsequent intensive braking. During intensive braking, the motorcycle lost its directional stability, crossed into the opposite lane, and then fell onto the road. At the time of the collision, the motorcycle was sliding on the road with its right side. First, the left front wheel of the agricultural machine ran over the motorcycle and then over its left rear wheel, as a result of which the kinetic energy of the motorcycle was converted into deformational energy, which caused that the motorcycle stopped. The motorcyclist's body was pushed by the left front wheel of the agricultural machine towards the final position. On the place of the traffic accident, the motorcyclist died in result of severe injuries (the immediate cause of death was extensive combined crushing injuries to several organ systems of the motorcyclist's body) [9].

Fig. 1. View from the motorcyclist's driving direction [9]

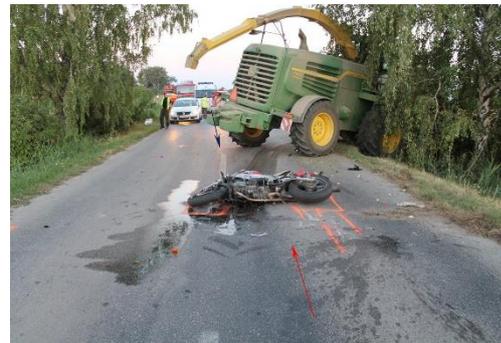
After the collision, there were specific braking conditions for the agricultural machine. Under the left front wheel was the body of the motorcyclist, which left a trail of motorcyclist fibre on the road. Applying this trace to the road caused a decrease in the adhesion conditions between the wheel and the road. Despite the reduction of adhesion conditions, the agricultural machine did not turn to the right due to the asymmetry of braking. The turning of this machine to the right only happened in the section, when the right wheel left the road, and went into the ditch. The following pictures show a view of the place after the traffic accident from the direction of the motorcyclist (Fig. 1), where the brake mark from the wheel of the motorcycle is shown – blue arrow) and a view from the direction of the agricultural machine (Fig. 2), where the brake mark is shown from the agricultural machine – red arrow).

Fig. 2. View from the driving direction of the agricultural machine [9]

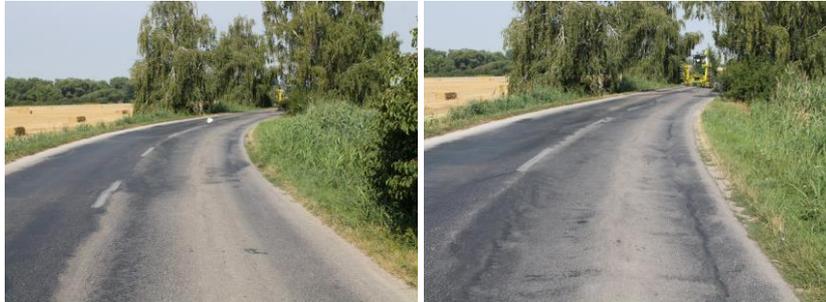
Fig. 5 (left) shows the approximate situation at the moment when the motorcyclist can see for the first time that another road user is moving in the opposite lane. At this moment, the motorcyclist could not recognize that the agricultural machine was encroaching in the opposite lane with its left machine part. This fact was recognizable only when the motorcyclist had a view of the entire width of the agricultural machine (Fig. 5 on the right).

Fig. 5. View from the motorcyclist's driving direction [9]

At the moment when the motorcyclist was able to recognize that the agricultural machine was encroaching into the opposite lane, the width conditions on the road were such that a corridor of approx. 2.4 m remained for the motorcyclist to drive (the agricultural machine was encroaching into the opposite lane by approx. 0.6 m). About 2.7 seconds remained until the moment of collision (with the motorcyclist moving at an average speed of  $75.5 \text{ km}\cdot\text{h}^{-1}$ ). When the motorcyclist was driving approximately in the middle of his lane, such situation happened, with the same constant driving of the agricultural machine and the motorcycle (in the same transverse position as at the beginning of the accident scene), where it would not be possible for them to pass safely.
